Manhole Inspection Summary

Manhole # S33CC2006MH

Location Address: **214 CHURCHWARDENS RD**

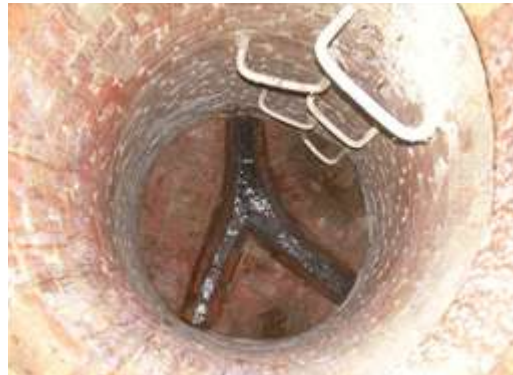
Top View

Bench debris.

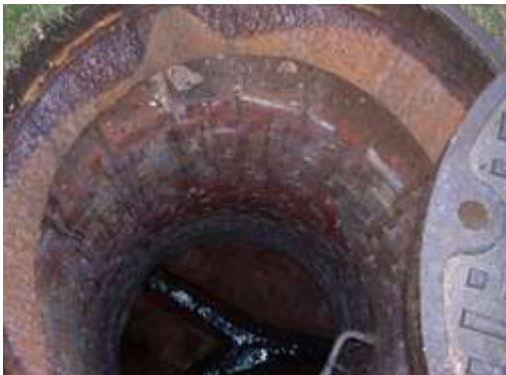
Defect

Frame offset. Adjustment deterioration and infiltration. Corbel and Barrel infiltration - other side.

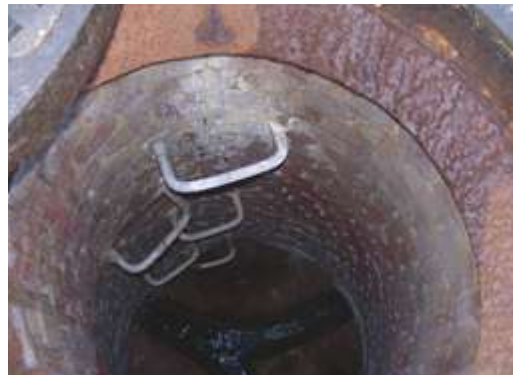
Defect

Adjustment, Corbel, and Barrel infiltration.

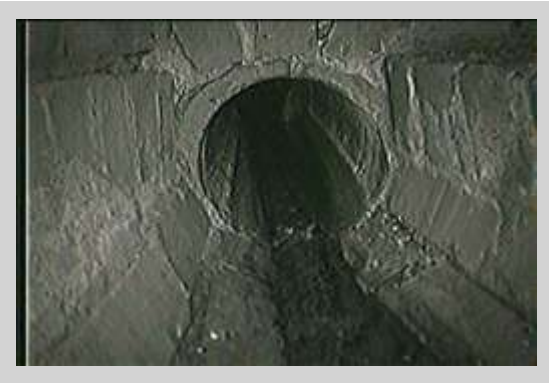
8 in. Circular Gravity Sewer Pipe Out @ 12 O'Clock

Deposits: ☐ None ☐ Mud ☐ Sludge ☐ Debris ☒ Grease

Silt Depth: **0** (in.) Deposits Extent: **Light**

Infiltration: **Evidence** Pipe Seal Cond: **Cracked**

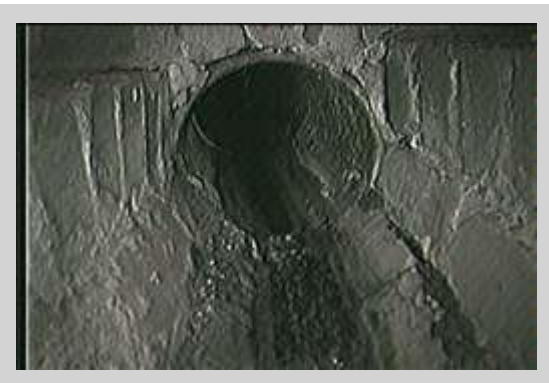
8 in. Circular Gravity Sewer Pipe In @ 4 O'Clock

Channel deterioration.

Infiltration: **Evidence** Pipe Seal Cond: **Cracked**

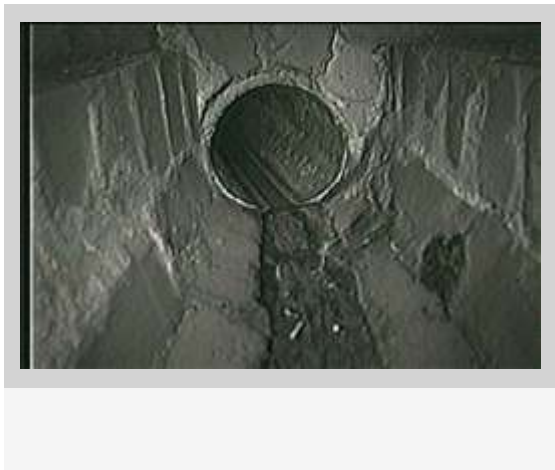
6 in. Circular Gravity Sewer
Pipe In @ 7 O'Clock

Infiltration: **Evidence** Pipe Seal Cond: **Cracked**
